## **Class 60 Traction Motor - PE Endbell Sept 2011 – Aug 2012**

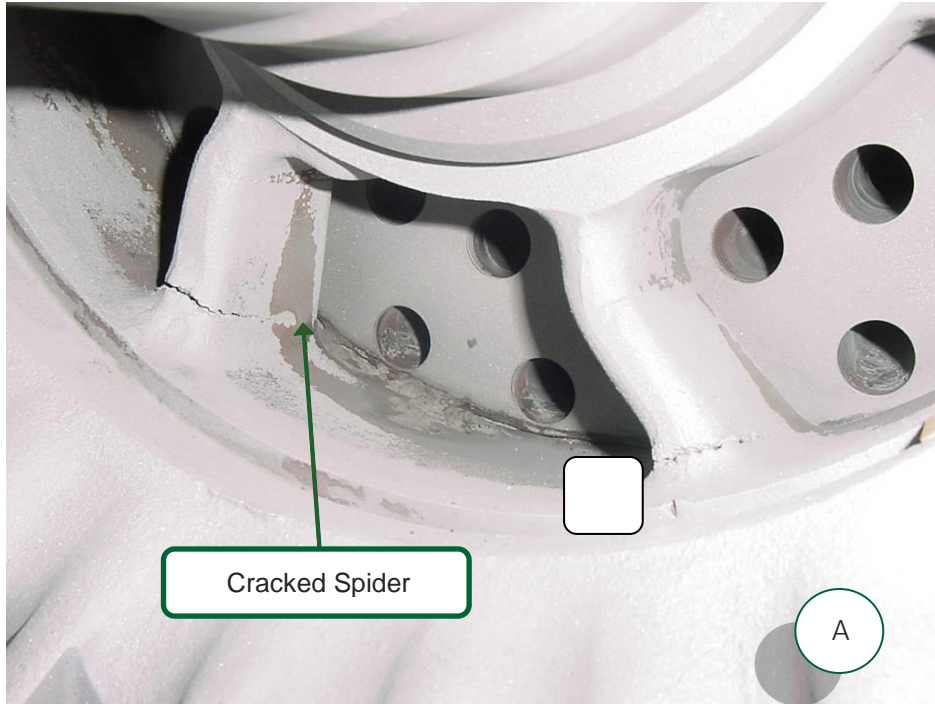
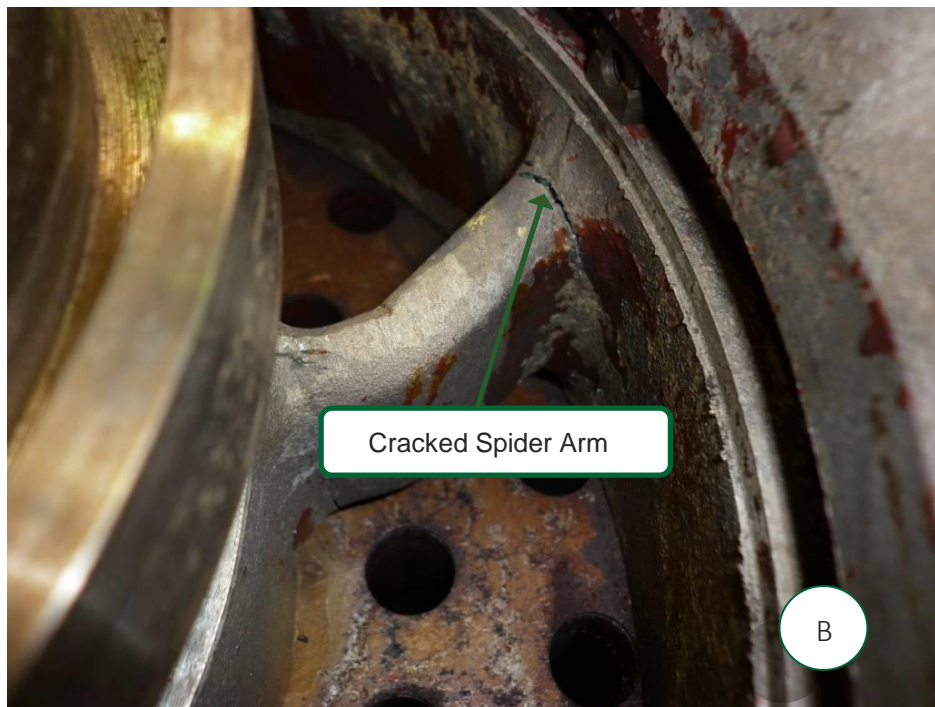
During the disassembly of the traction motors at routine overhauls several of the armatures were found to have severe damage to the PE Endbell. The cast aluminium PE Endbells that support the armature windings were found to have structural cracks between the support boss and spider arms as indicated in the photos 1 and 2 below.

The cause of the failures is most likely speed or inertia related fatigue. Failure to address the damage to the PE Endbell would most likely lead to catastrophic armature failure.
